**GEOTECHNICAL INVESTIGATION - McTEER ROAD
FROM COUNTY ROAD 17 TO CITY BOUNDARY
F18-QT-2019-023
CITY OF CLARENCE-ROCKLAND**

PROJECT: Geotechnical Investigation- McTeer Road Rehabilitation
 CLIENT: City of Clarence-Rockland
 LOCATION: McTeer Road, Clarence-Rockland, Ontario
 DATE: June 25, 2019

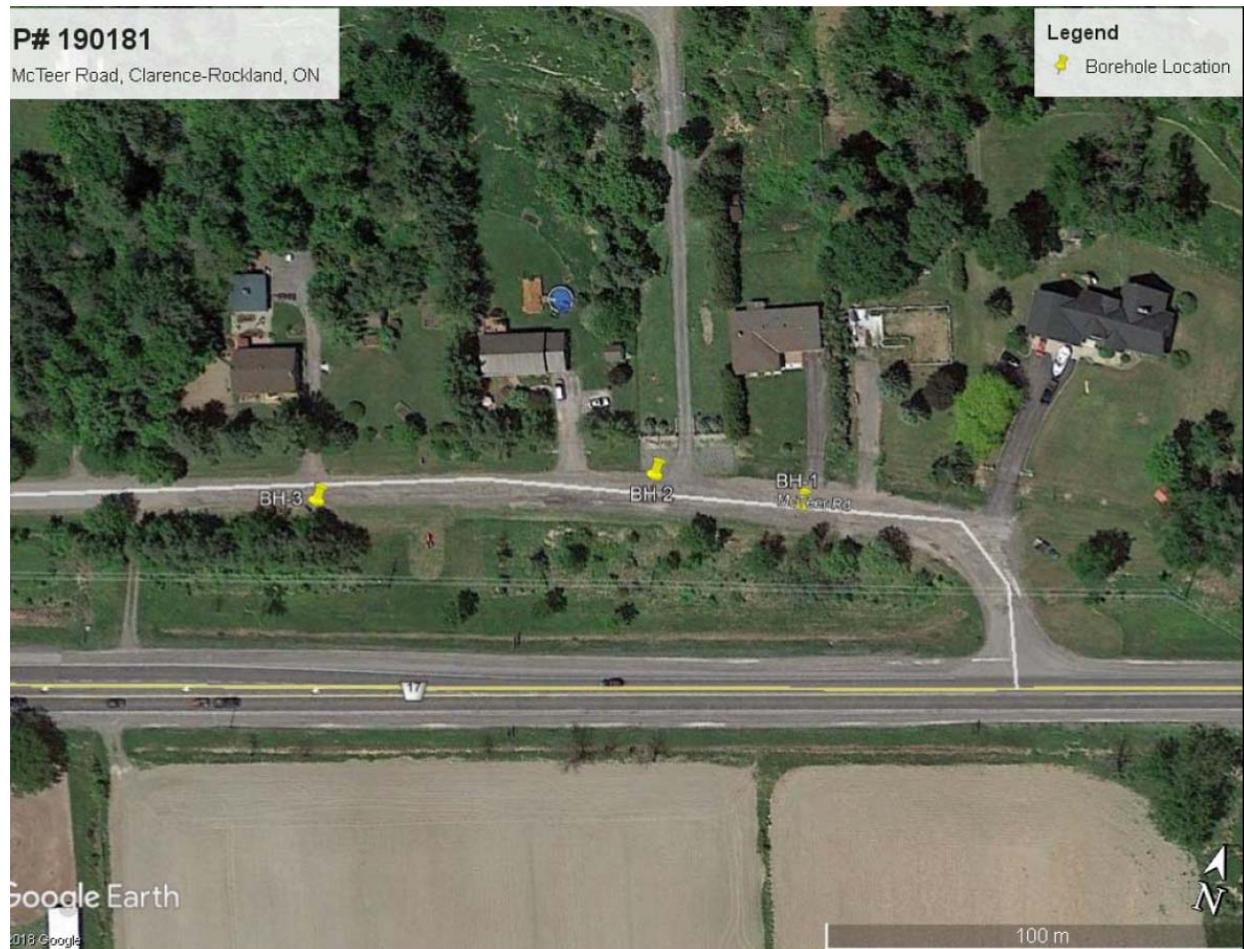
Figure 1: Borehole Location

All boreholes were located using a GPS (Global Positioning System) receiver using NAD 83 (North American Datum). Using these GPS coordinates, the borehole locations were plotted on a Google Earth aerial image. The location of the boreholes is presented as part of **Figure 1** below.

Item	Depth of soil interface (mm)		
	BH-1	BH-2	BH-3
Northing	474047	474013	473941
Easting	5041421	5041417	5041387
Asphaltic Concrete	NE	30	125
Granular Crushed Stone	480	430	450
Subgrade Condition	Clay	Clay	Clay
