**LIMITED PHASE II - ENVIRONMENTAL SITE ASSESSMENT
CLARENCE ARENA EMERGENCY EXIT STAIRS REHABILITATION
418 LEMAY STREET
CLARENCE-CREEK, ONTARIO**

The City of Clarence-Rockland
Attn: Mr. Charles Boneau, Coordinator, Capital Projects
1560 rue Laurier Street
Rockland, Ontario
K4K 1P7

Lascelles Engineering & Associates Limited
1010 Spence Avenue, Suite 14
Hawkesbury, Ontario
K6A 3H9

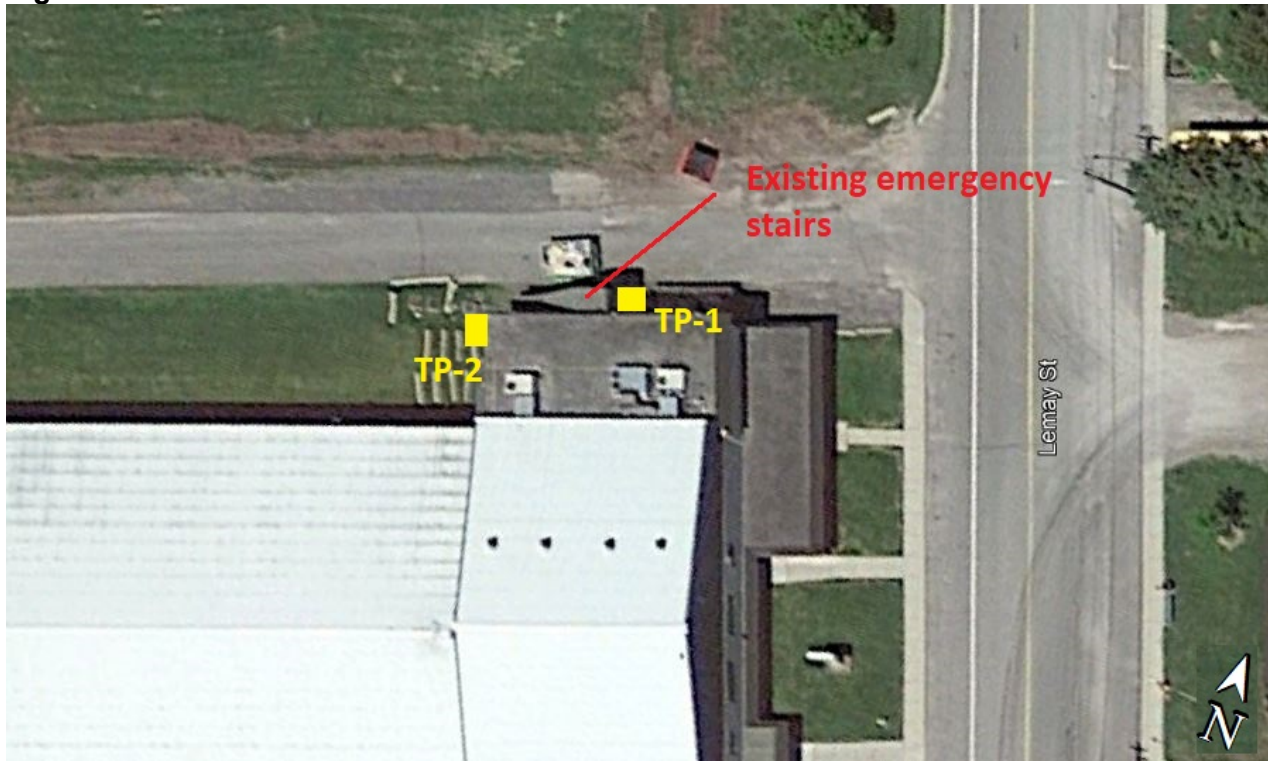
Figure 2: Test Pit Location

The fieldwork for this investigation was carried out on January 29th, 2020 and consisted of digging two (2) test pits; one on each side of the existing stairs. It is noted that it was impossible to dig a third test pit to the north of the stair due to the presence of the gas line and watermain in the vicinity. Prior to any fieldwork, the test pit locations were cleared for the presence of any underground services and utilities. The approximate locations of test pits are shown below as part of **Figure 2**.
