ASSET MANAGEMENTPLAN

This Asset Management Plan is intended to describe the infrastructure owned, operated, and maintained by the City of Clarence-Rockland to support its core services. It is a compilation of many documents that describe the evolution of the Asset Management implementation in Clarence-Rockland over the past few years aligned to the content and format described in the Province of Ontario's Guide for Municipal Asset Management Plans.

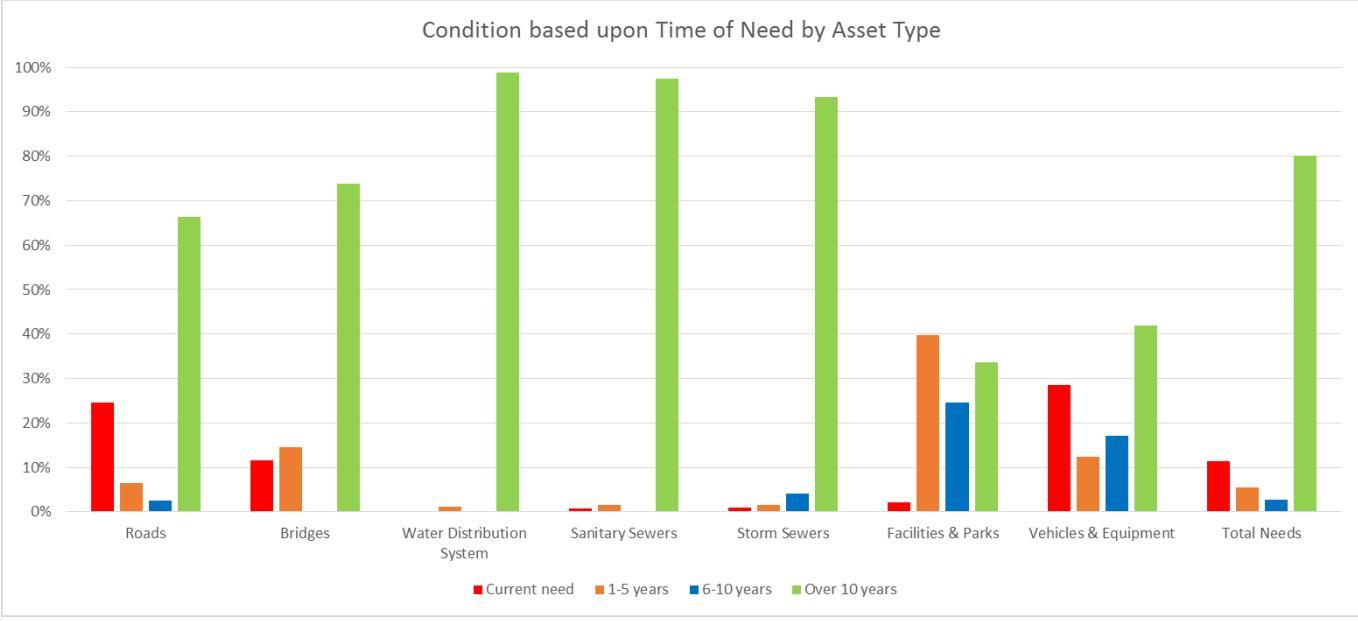
Figure 3: Condition based on Time of Need by Asset Type

In assessing the municipality's state of the infrastructure, we examined, and graded, both the current condition and remaining service lives of the asset categories as well as the municipality's financial capacity to fund the asset's average annual requirement for sustainability (Funding vs. Need). The City's infrastructure ranges in condition by asset type in terms of time of need as shown in the chart below. Note: these numbers are based on condition assessments that have been completed and age. Updated condition assessments, particularly for water, sanitary and storm, may result in additional requirements. The recommended approach includes a combination of time of need and replacement planning (See Table

While the underground infrastructure is relatively new and in good condition, the roads network has a 61% adequacy rating with over \$36 million of "Now" needs based upon its adequacy rating. Similarly, structures (bridges and culverts) were found to have an adequacy index of 56% and significant "Now" needs of \$1.6 million. As well, investments of over \$2 million are required in the next 5 years. Therefore, this is a high priority area for the City in order to maintain or improve the state of its roads/structures infrastructure.

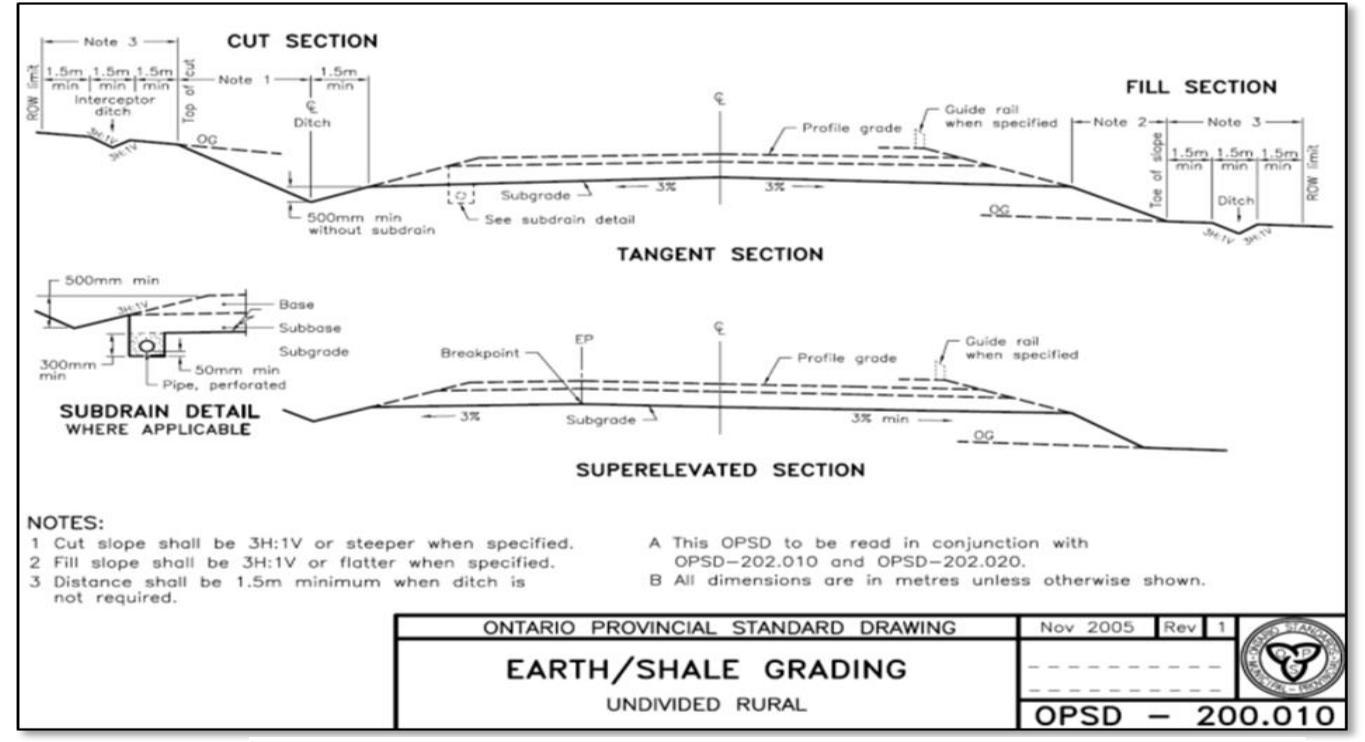
Figure 7: OPSS 200.10

Urban roads typically have a storm sewer pipe network that carries the minor storm event. The roadway itself is often part of the overland flow route for the major event. The drainage of the granular road base is accomplished through sub-drains installed below the curb and gutter, lower than the lowest elevation of the granular base. This satisfies the same purpose as the ditch in a rural cross-section, by providing an outlet to ensure that the granular base remains dry

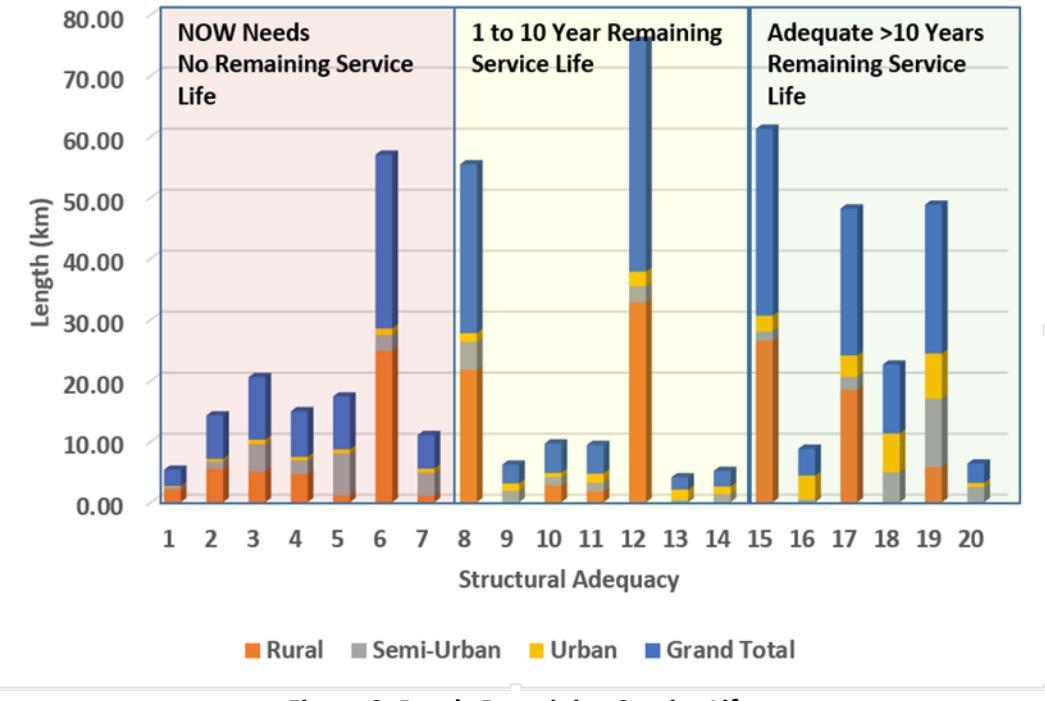
Figure 9: Roads Remaining Service Life

As indicated previously, the Time of Need is really a prediction model in terms of an estimate based on current condition to the time for reconstruction. The TON then also provides an estimate of the remaining life in the road system/section. The following figure summarizes the structural adequacy ratings of the road system and illustrates the estimated remaining service life of the road system.

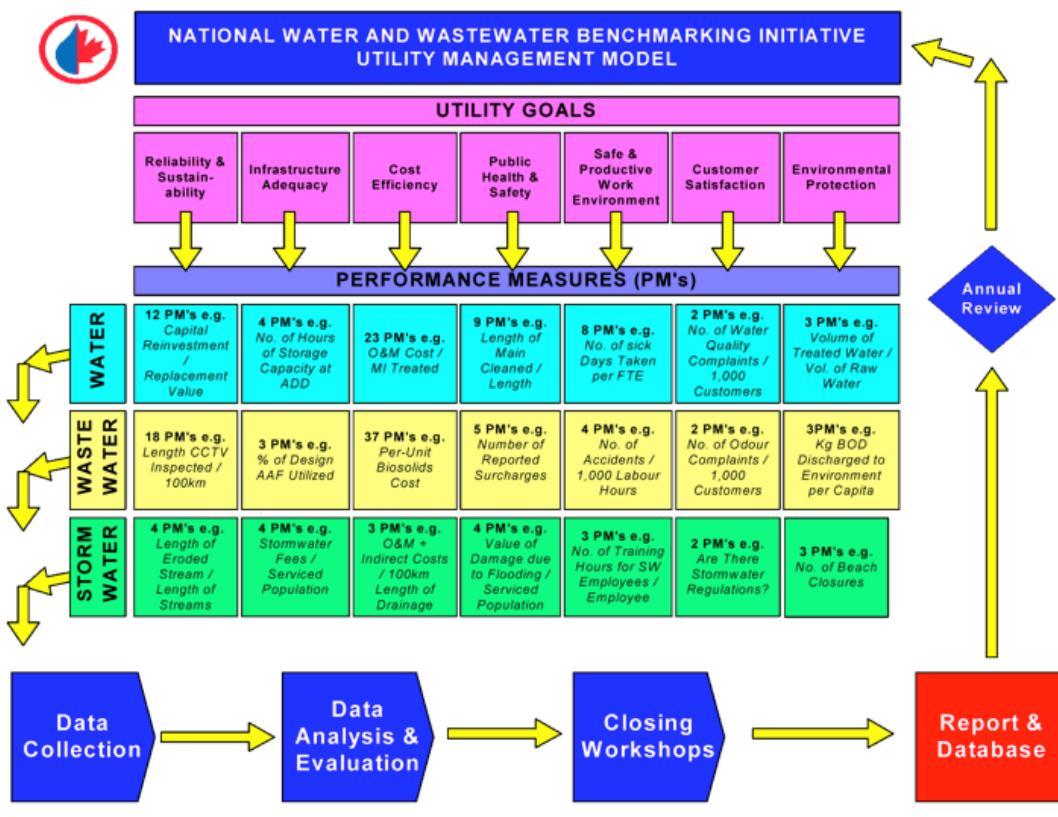
Figure 14: Performance Model of the National Water and Wastewater Benchmarking Initiative

Condition ratings for the storm and sewer network can be based on objective CCTV inspections or subjective scales. About 73% of storm and sewer network in Clarence-Rockland has been inspected by CCTV. The rest has not been rated yet. For the water network, the city will conduct a study for a full hydraulic model of the network.

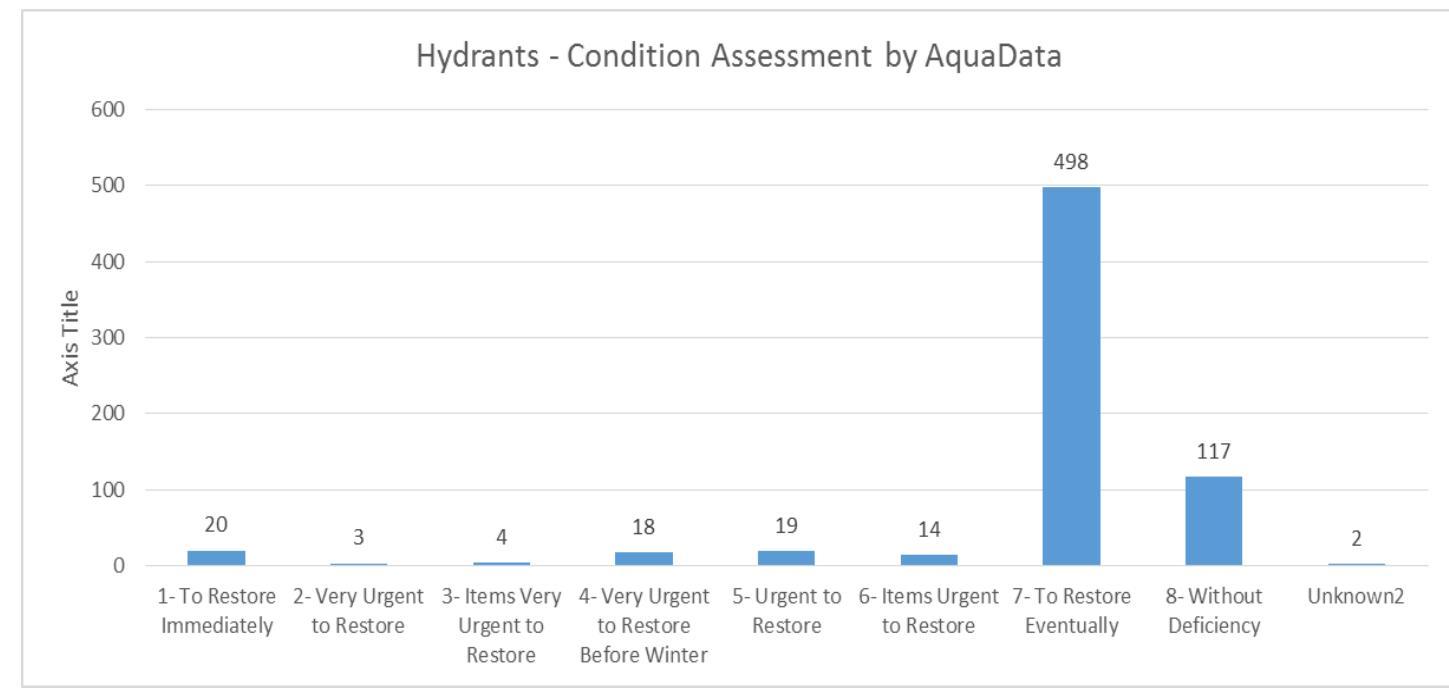
Figure 19: Hydrant Condition Assessment by AquaData

An assessment was conducted by AquaData in the Fall of 2013 and shows that the overwhelming majority of these are in good or excellent conditions. Figure 19 shows the condition Ratings for Fire Hydrants.

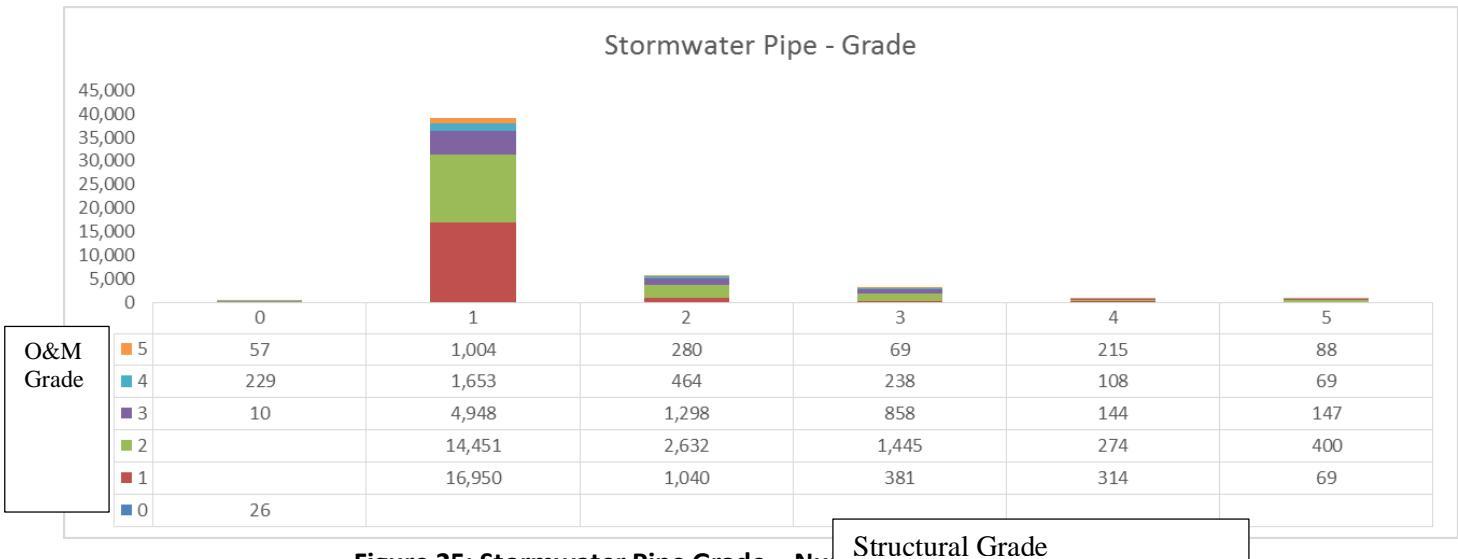
Figure 25: Stormwater Pipe Grade – Nulmer or meters

Figure 24 and 25 show the condition ratings of pipe both in terms of structural grade and O&M Grade. The charts indicate that there are only

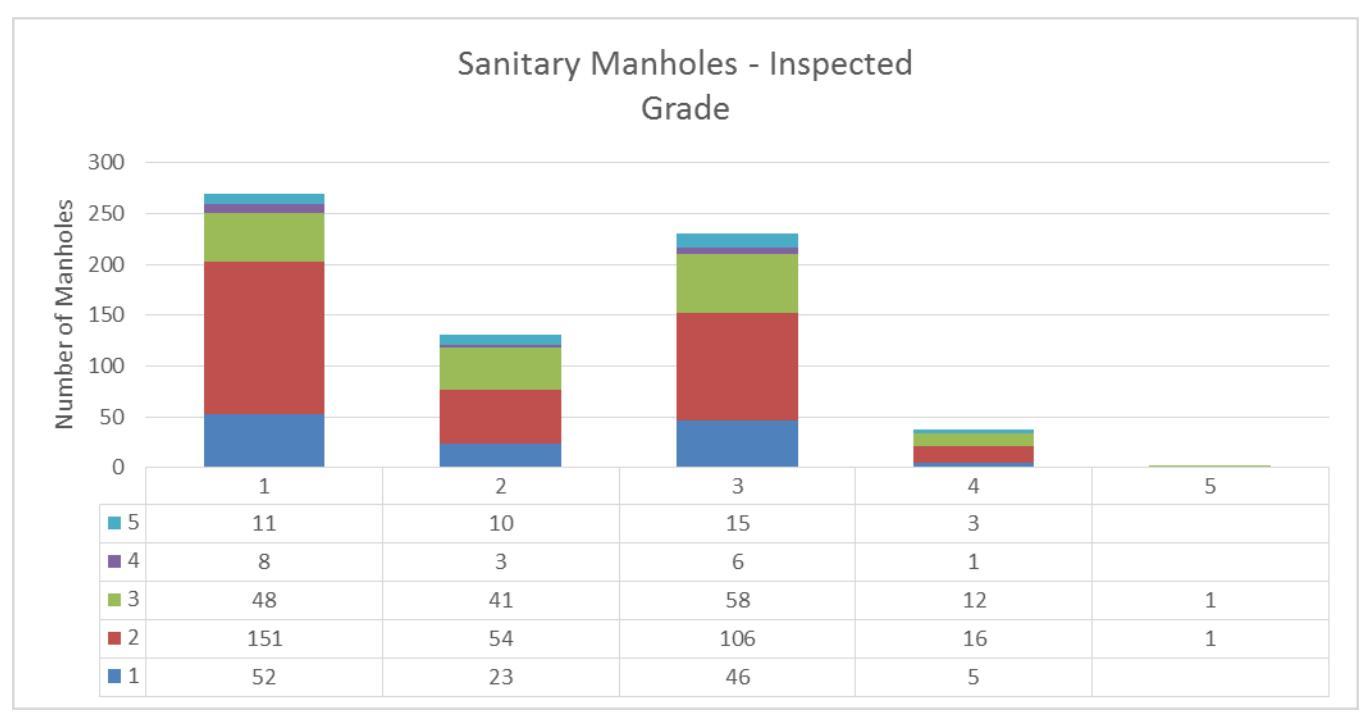
Figure 26: Sanitary Manhole Grade

The city has about 2,300 manholes in the sanitary and storm water networks. There are also about 1,300 catch basins for the storm water system. CCTV inspection was implemented on 65% of all manholes. Again, most of the manholes (60%) achieved a rating index of 1-3 in both the condition grades and the O&M conditions (with O&M slightly trailing condition grade index). Only about 5% of manholes were scored at the 4 or 5 levels.

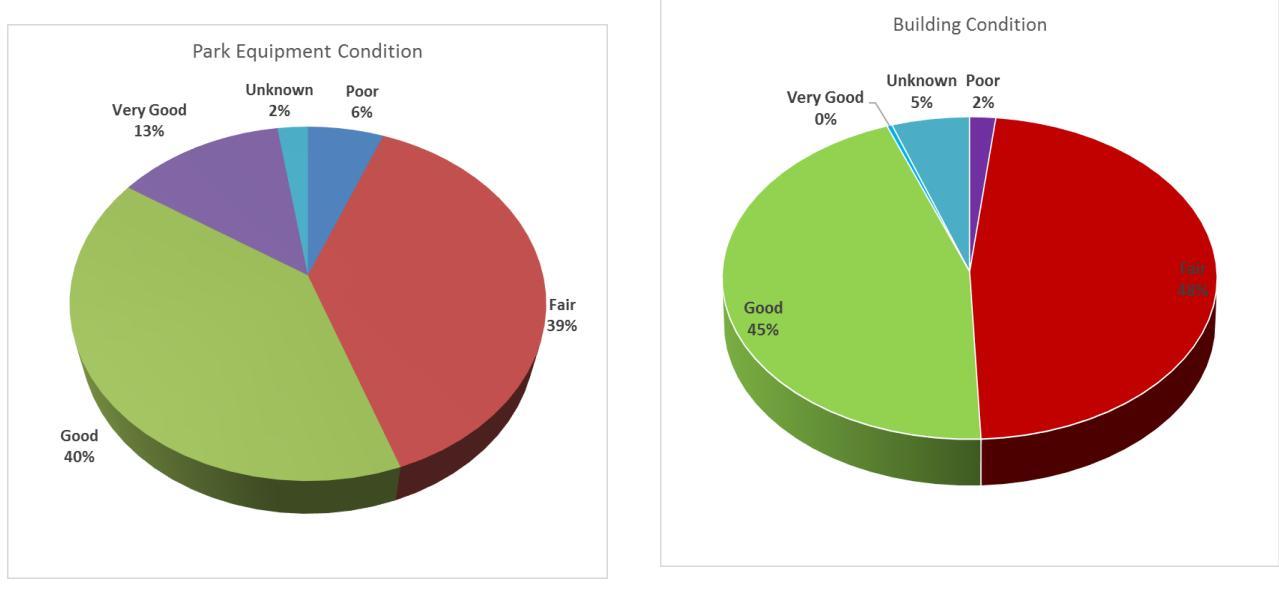
Figure 35: Parks Condition Rating

The condition assessment conducted by the consultants revealed that 53% of the park equipment and 45% of the buildings are in good to very good condition. The remaining are fair to poor or unknown.

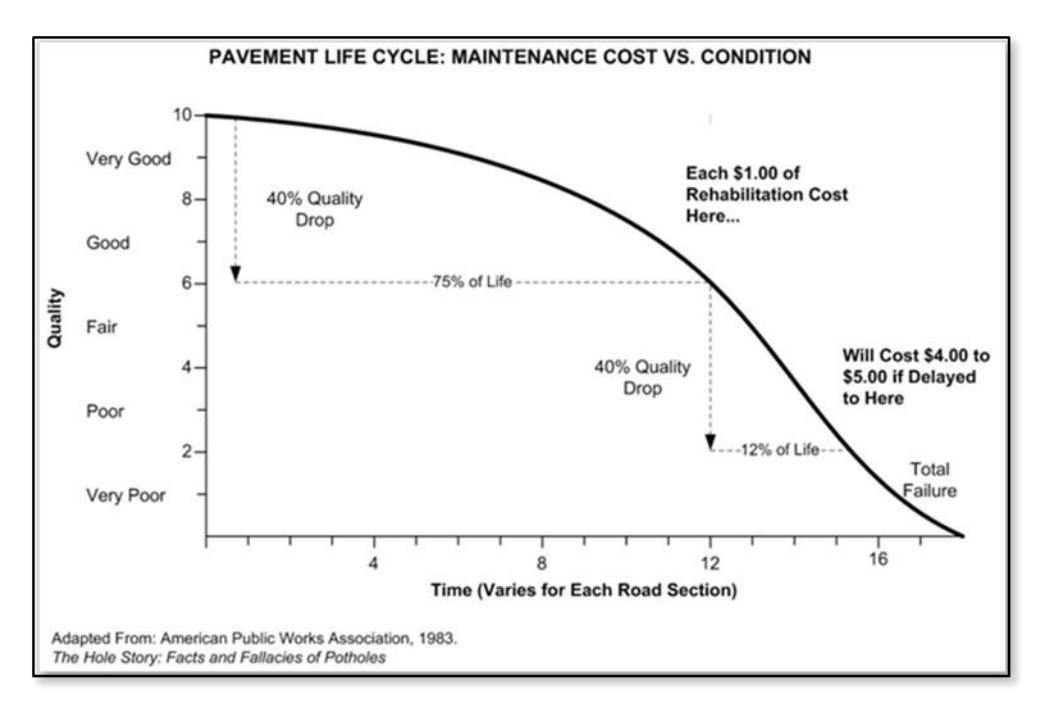
Figure 37: Treatment Cost vs. Deterioration

From a more current asset management perspective, project selection should be predicated by public safety and then condition Figure 37 is taken from a document that describes pavement management principles however, the concepts may be applied to other assets such as structures to optimize available funding. Figure 36clearly illustrates the financial advantages of managing an asset by performing the right treatment at the right time of the asset life cycle. If appropriate strategies are not undertaken at the correct time, there is a less effective usage of the available funding. For example bridge deck waterproofing and repaving and minor deck rehabilitations performed at the appropriate condition will optimize funding and utilize the full service life of the asset.

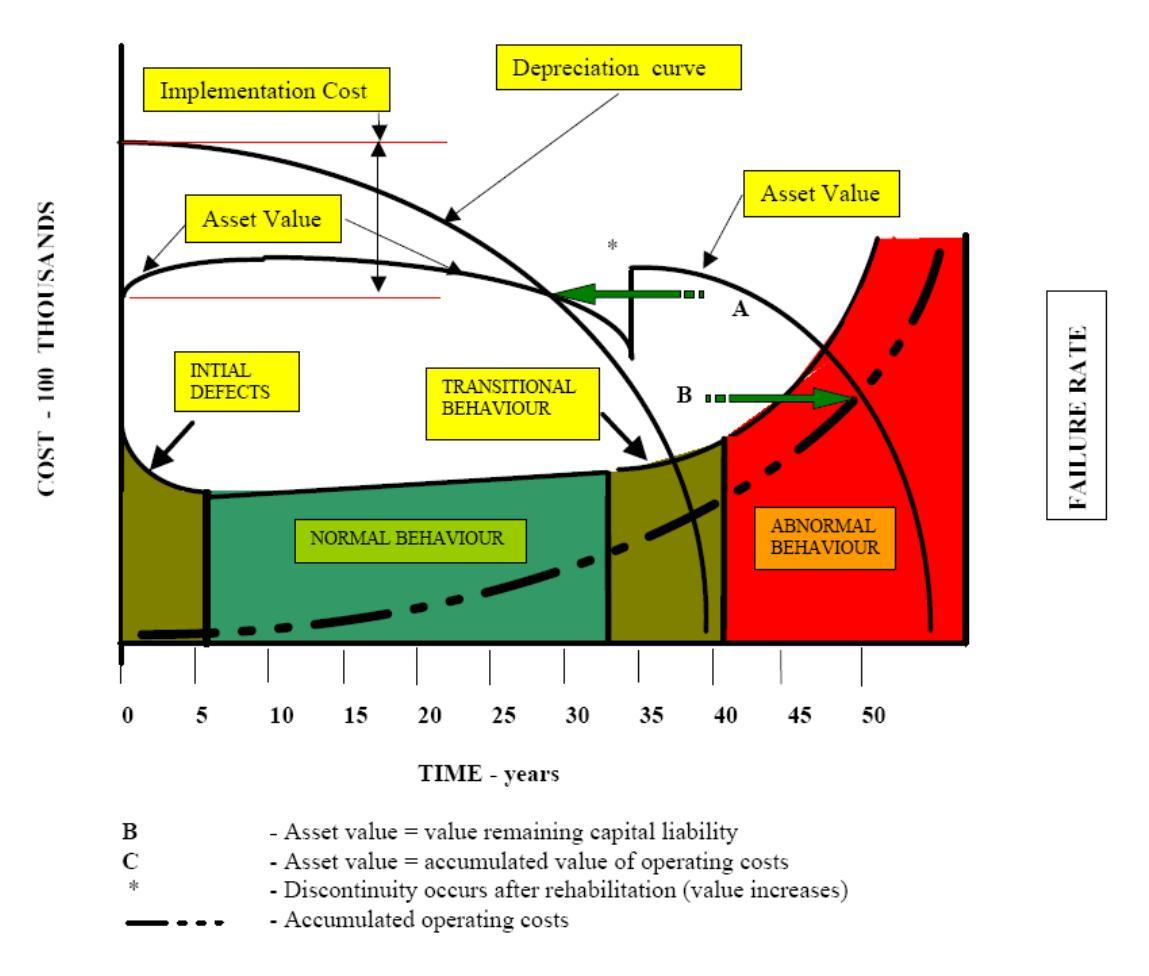
The following graph is from the Transportation Association of Canada's (TAC) Bridge Management Guide and illustrates what is referred to as a deterioration curve.

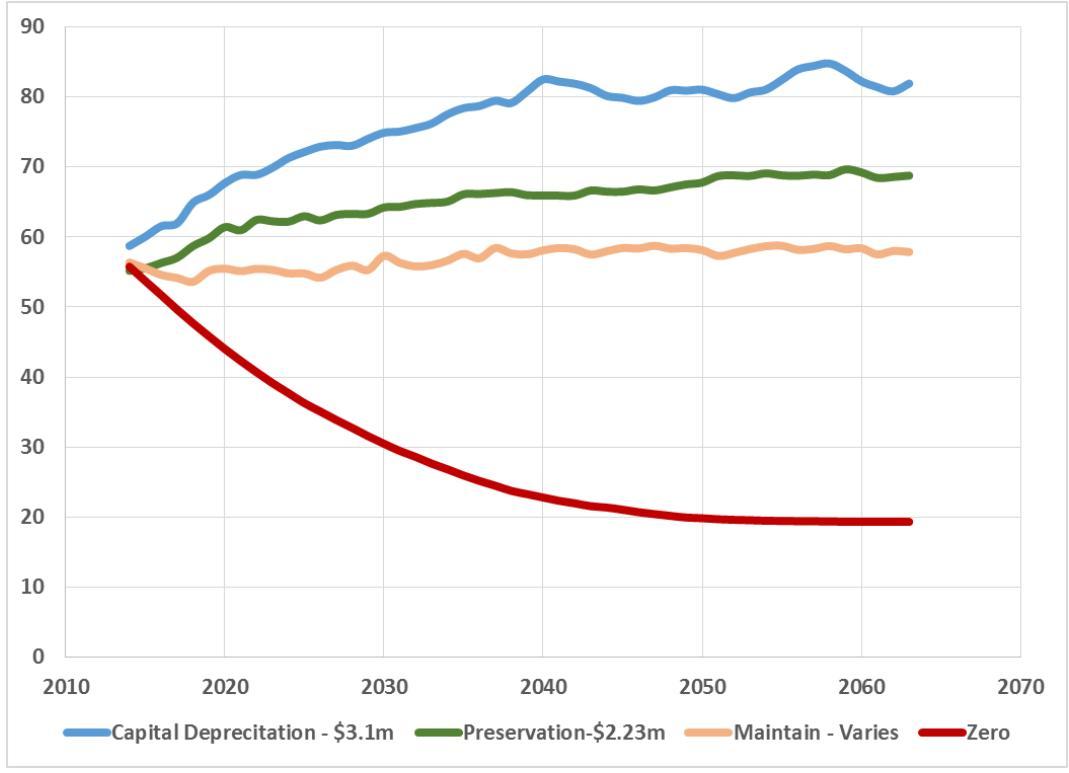
Figure 39: Performance Modeling at Various Budget Levels

The Weighted Average Physical Condition of the road system is currently 53.2. The performance model calculations all begin with the current Physical Condition and for purposes of the graphing, the year-end Physical Condition is displayed based on the effects that the improvements have had on the overall condition of the road system.

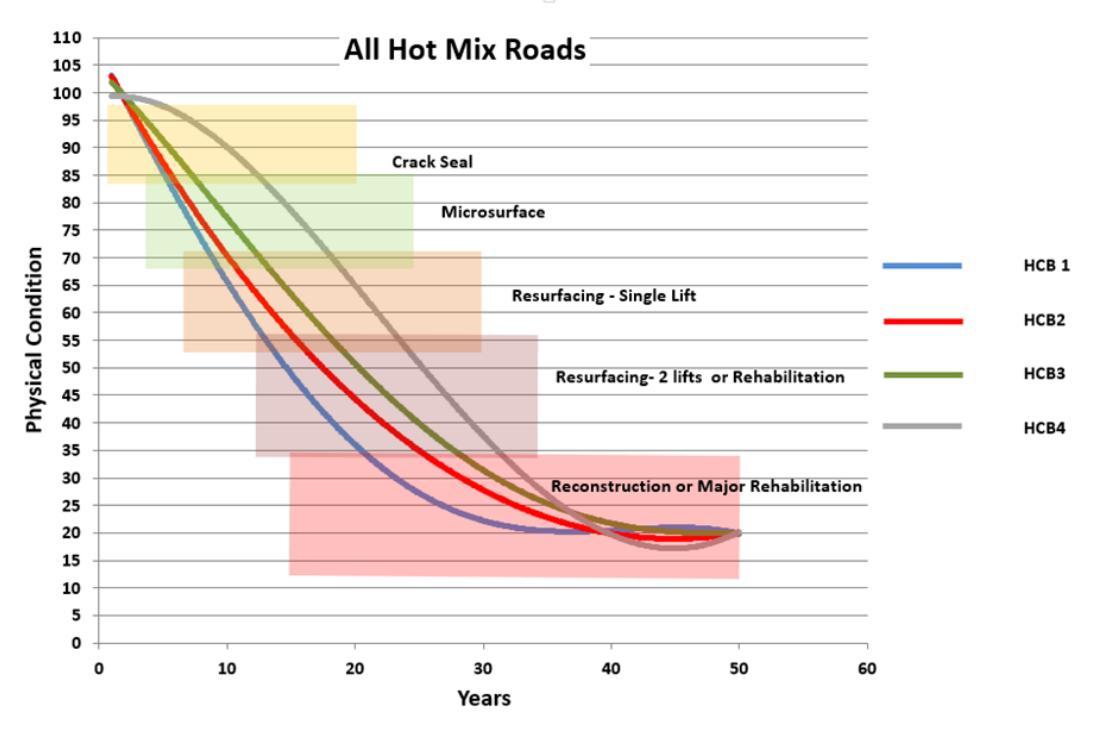
Figure 42; Treatment Selection vs. Condition

Figure 43 illustrates treatment selection by time and asset classes for hot mix roads. Typical treatments and/or improvements have been superimposed over the deterioration curves, to illustrate the general timelines for implementing the treatments. Other road asset classes have been treated similarly. An important concept to remember is that as a road deteriorates the cost of rehabilitation increases. The deterioration curves, improvement types, current unit costs and current condition ratings are essentially the assumptions used to develop budget and programming recommendations in this report. Appendix E provides detail on the deterioration curves for all road asset classes.

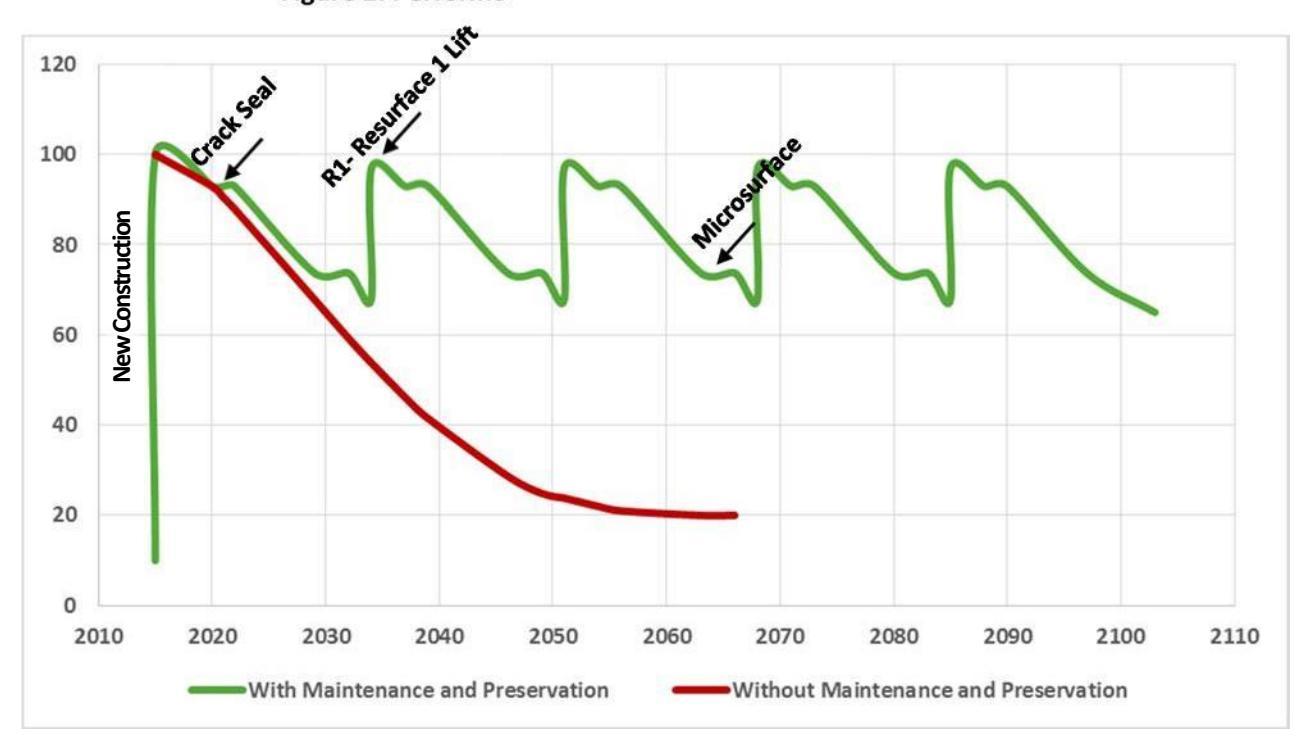
Figure 2: Performance Model – Effect of Treatment on Asset

Figure 2, shown below, illustrates several different aspects of performance model output including the effect of a treatment on an asset and the effect of multiple treatments undertaken at the optimal asset condition to produce a cost effective management strategy.
